**LsDyna3D Simulations and Analysis of
Polish Governmental Airplane TU-154M
Crash in Smolensk, Russia, April 10, 2010**

Wiesław K. Binienda, Ph.D., F.ASCE

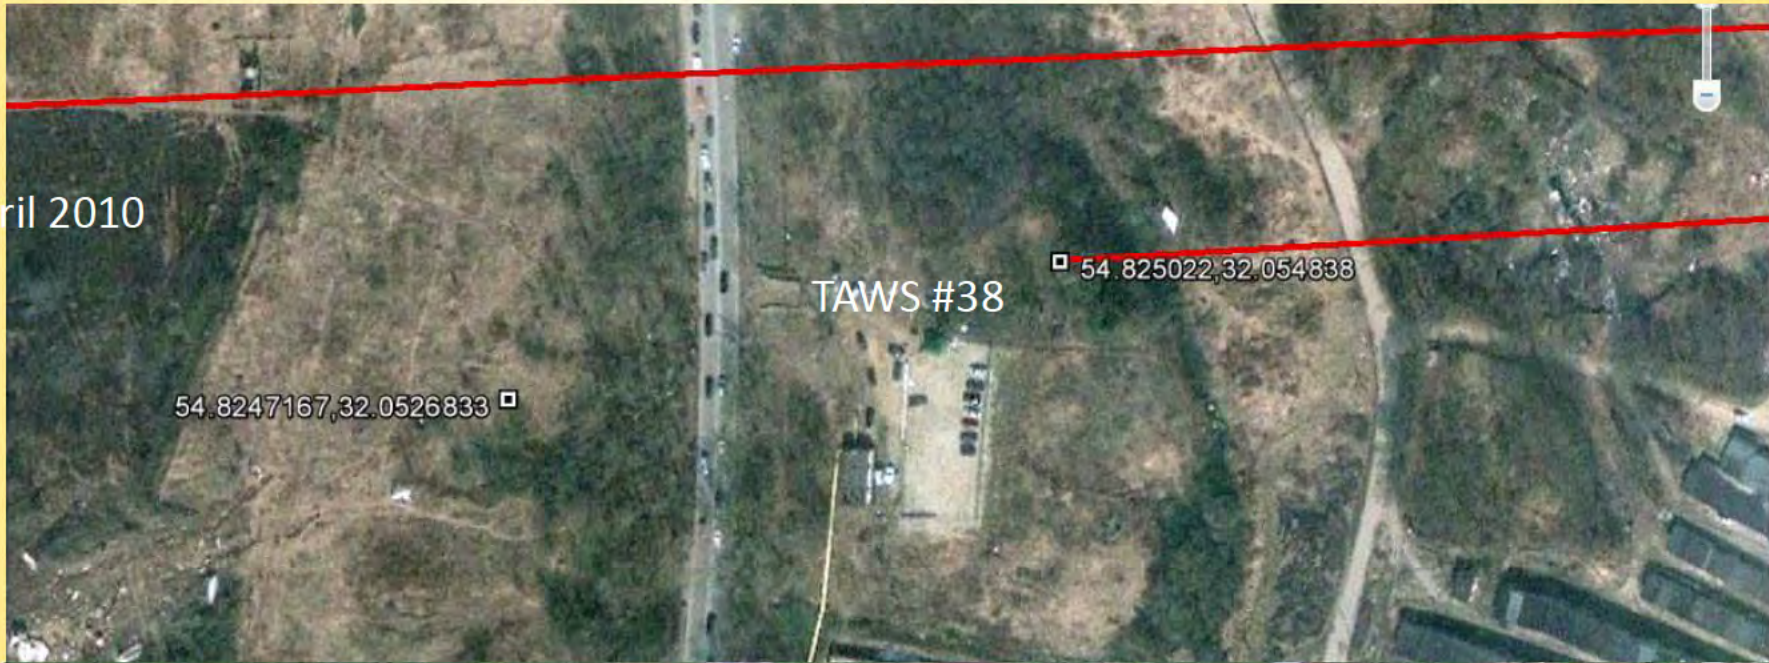
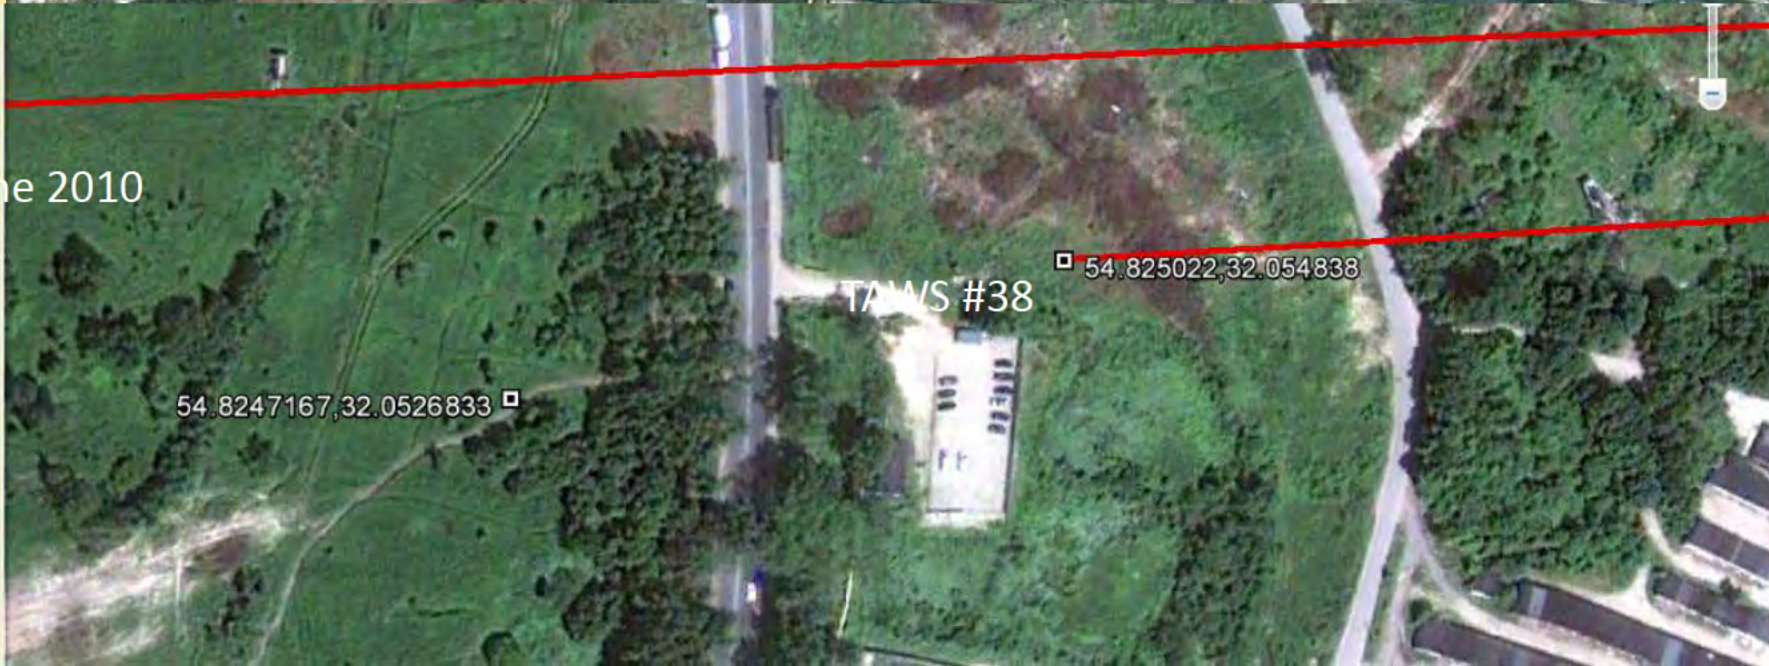
Satellite Images of the Area Where the Last TAWS Event Has Occurred (April and June 2010)

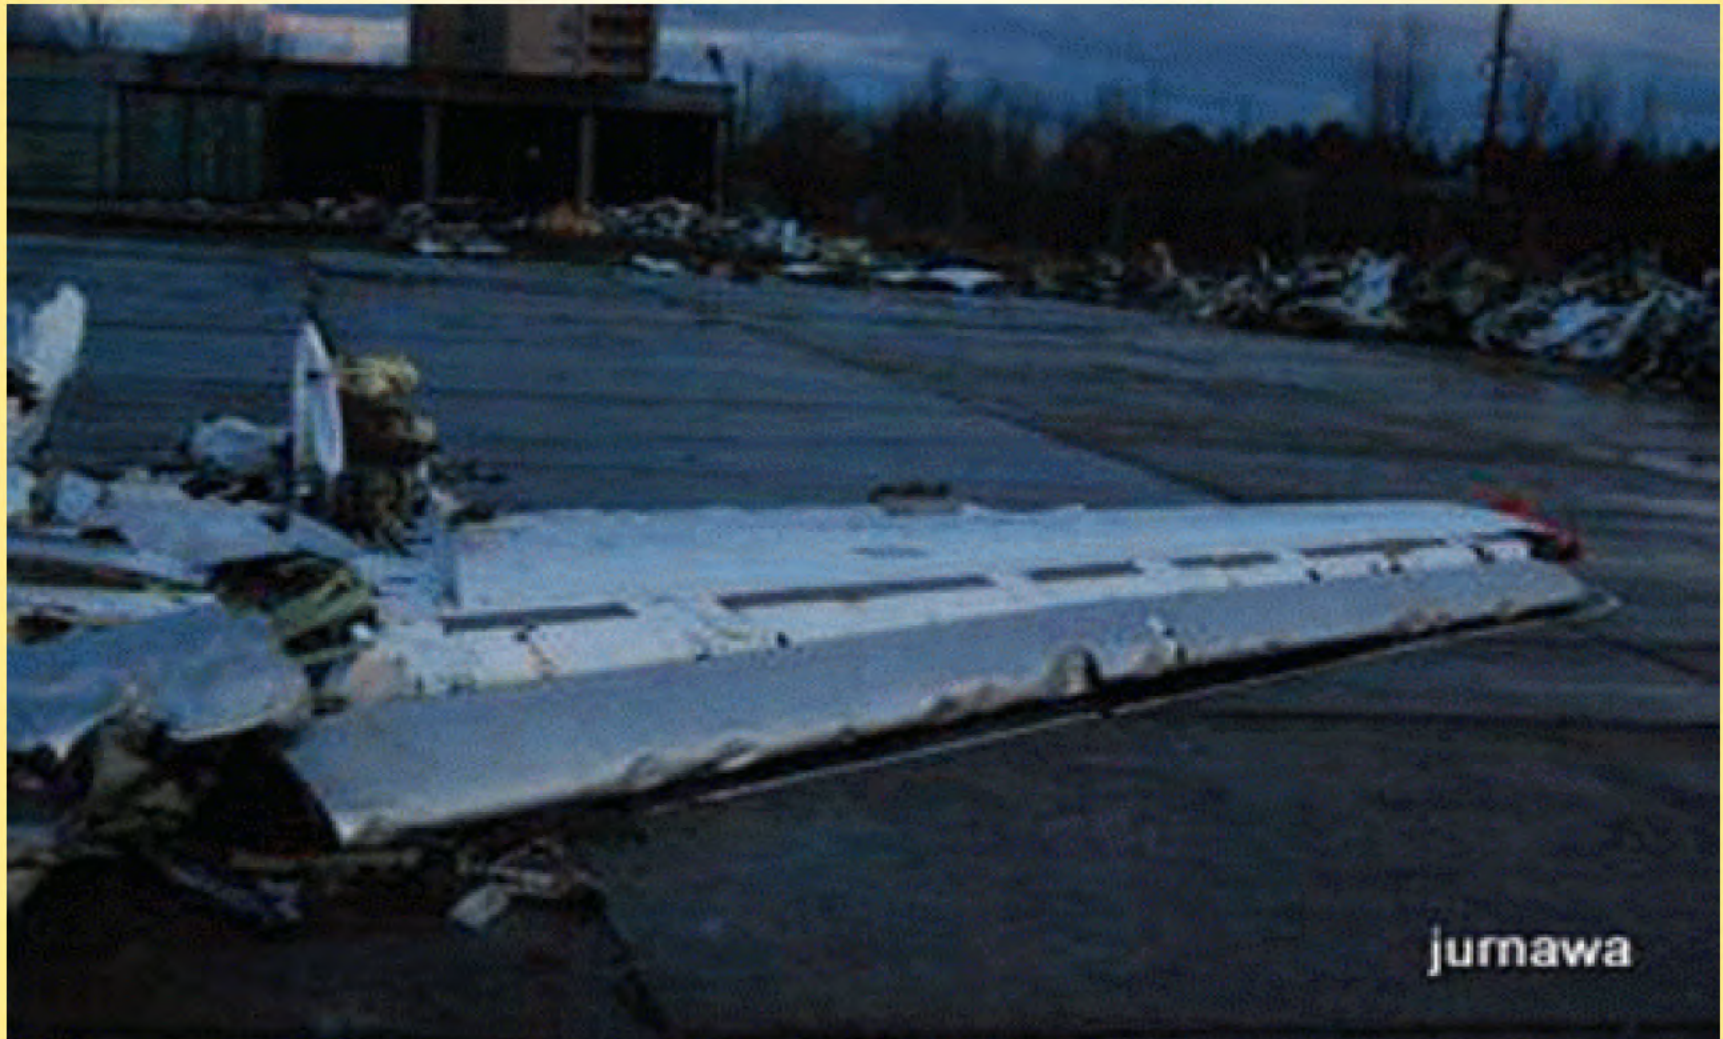
Front Slots are not Destroyed!

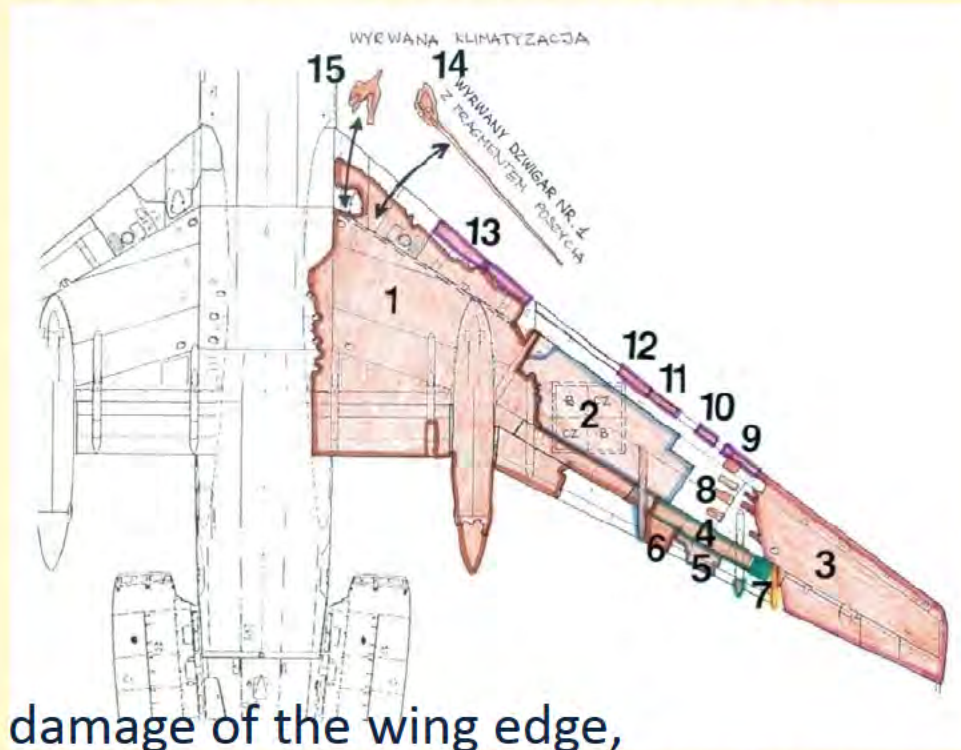
Left Wing Reconstruction View From the Bottom Up

- There is no visible damage of the wing edge,
 - real tree lays perpendicular to the airplane flight direction, and
 - there is an extensive internal wing damage including ripped off rivets
- suggest:
- there was no impact between the birch tree and the left wing, and
 - an explosion near the point TAWS could explain the damage of the wing
 - and rapid turn left of the airplane

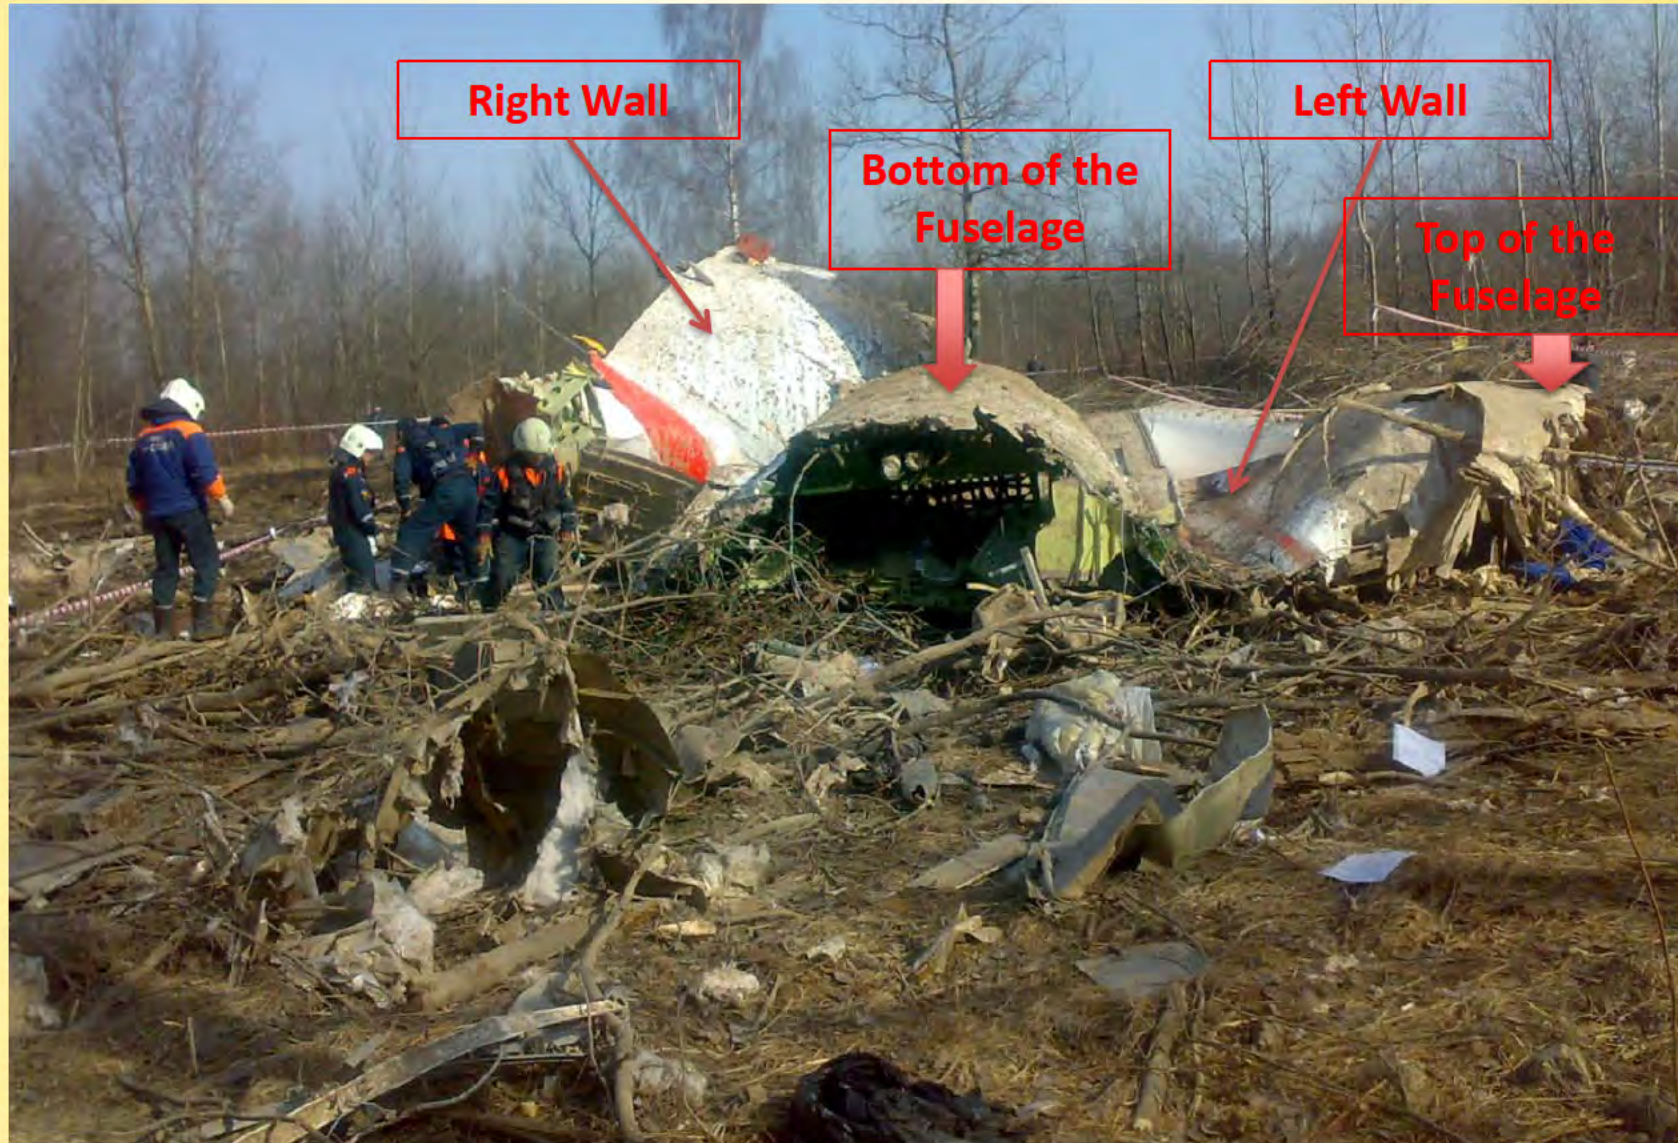
Both Fuselage Walls Open Outside

- Open walls outside of the fuselage indicate mid-air explosion.
- The unprecedented degree of damage and the large number of shrapnel indicate high energy mid-air explosion.

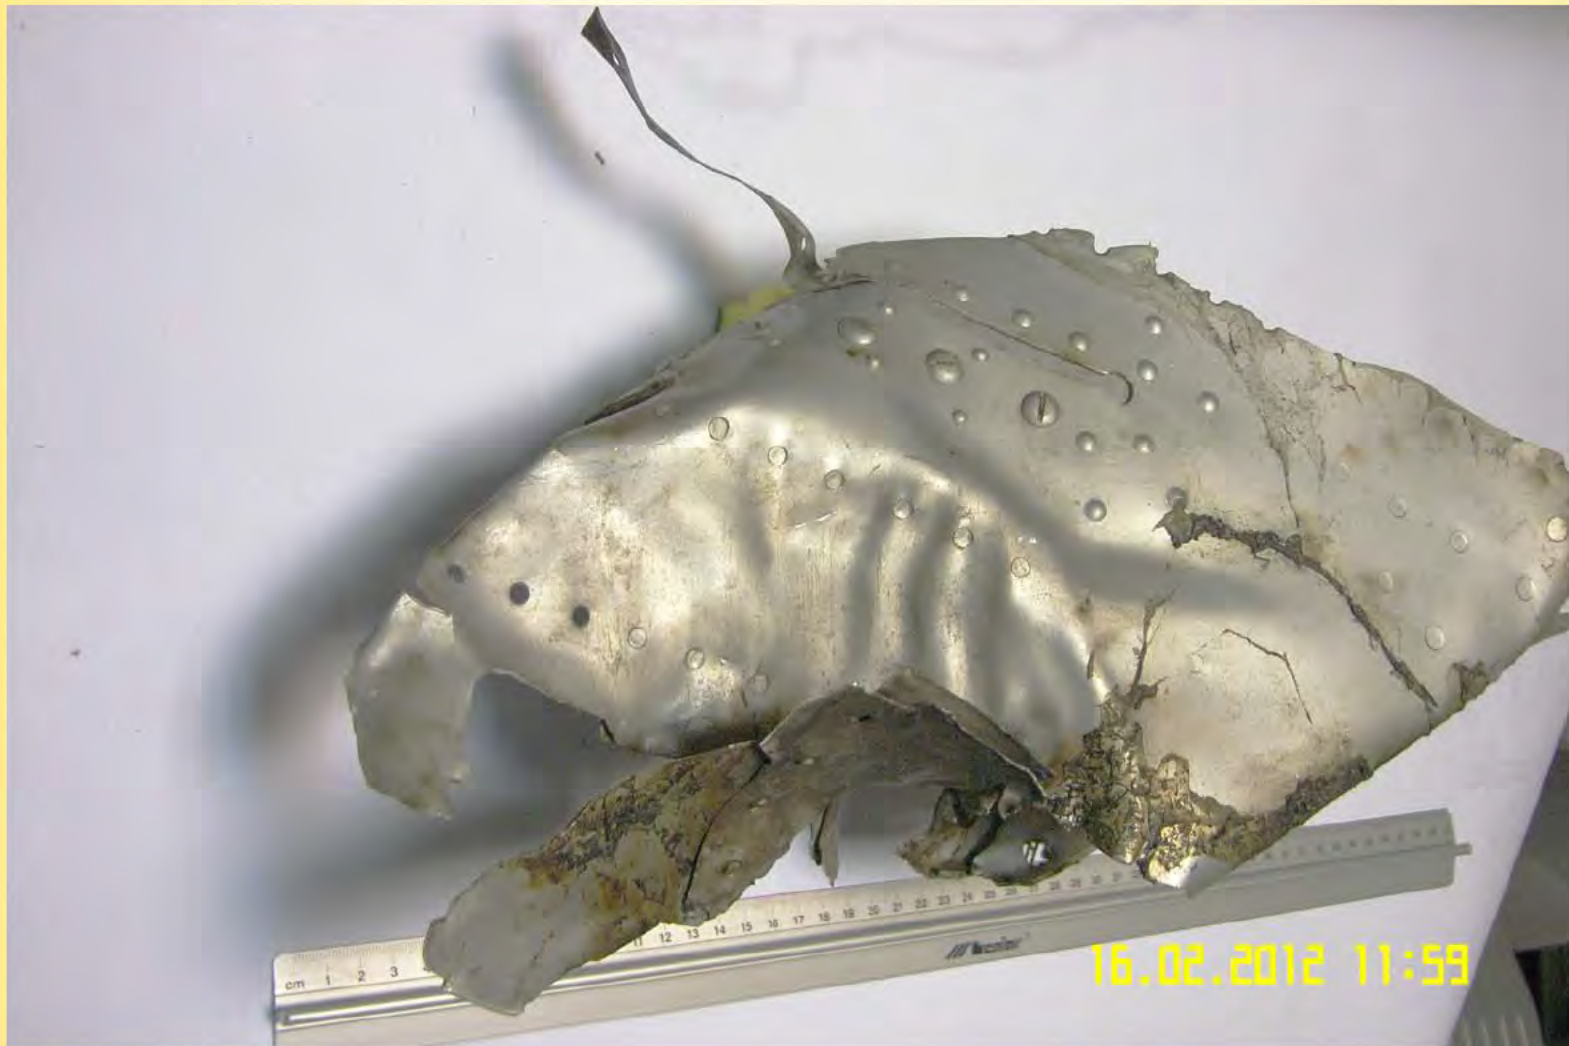
Shrapnel from Smolensk Crash Scene

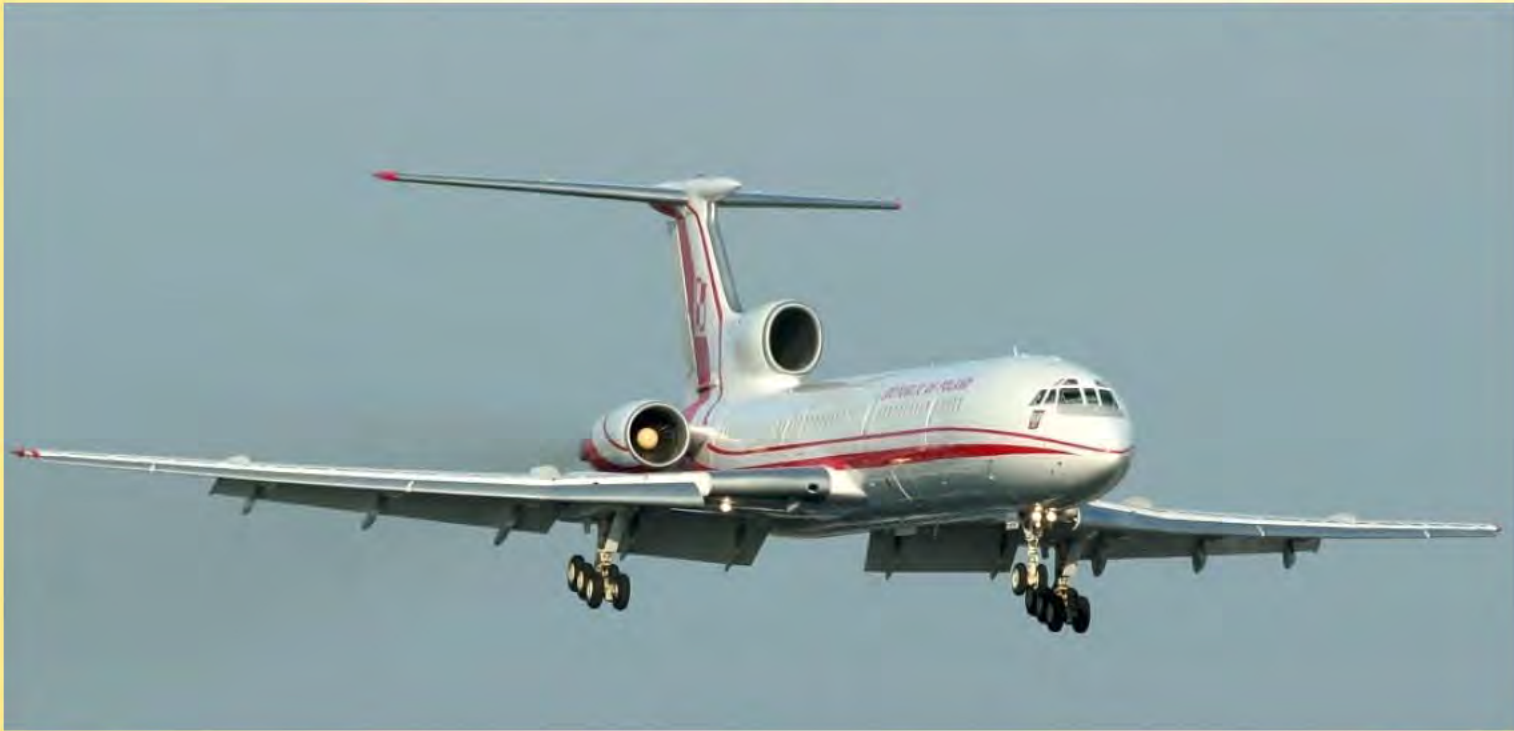
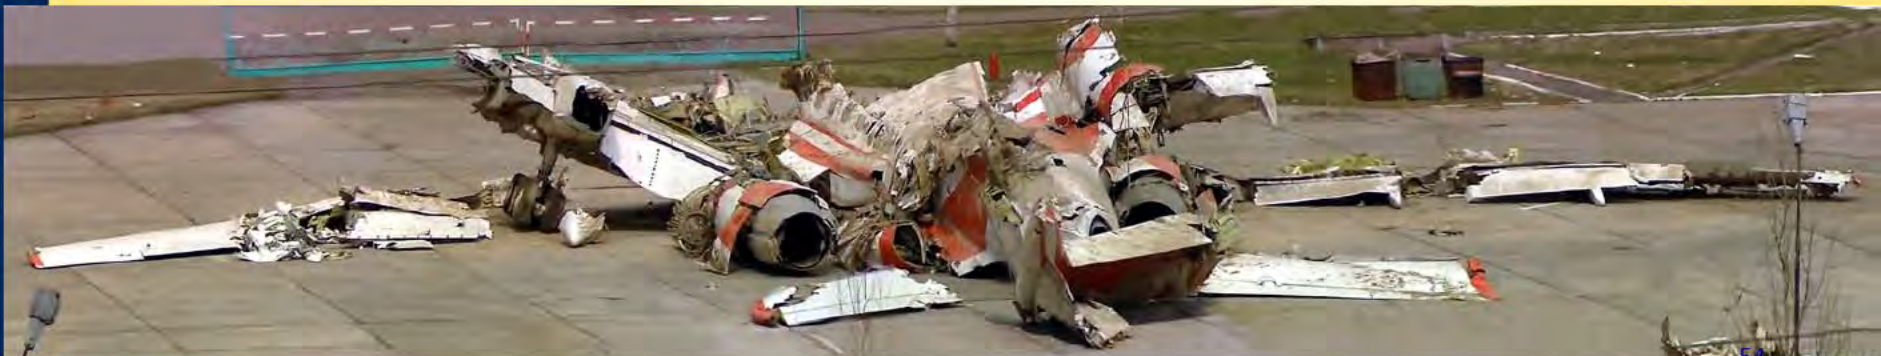
Airplane Tu-154M Crash Unusually High Disintegration
