Ohio Transportation Consortium

Undergraduate Research Internships to Support Exploratory Research in Transportation Engineering

Project Final Report

Sept. 2008

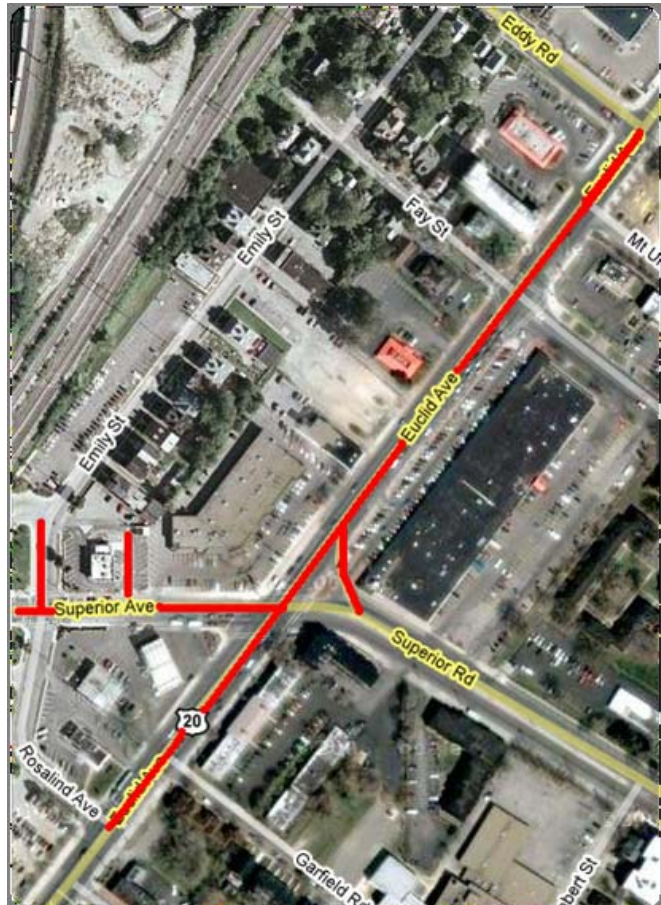
1. Euclid & Superior (N41° 31.394, W81° 35.376) - This site is centered on the intersection of Euclid Ave. and Superior Ave. in the City of East Cleveland. The site covers 1 block southwest and 2 blocks northeast on Euclid Ave. and 1 block to the northwest on Superior Ave. The area supports several fast food restaurants, two gas stations, and strip shopping centers. The site is served by a RTA train and RTA bus routes along Euclid Ave. and Superior Ave. The survey area includes the street pavements, the pavement around gas stations, and the strip shopping center parking spaces adjacent to Euclid Ave. There are 32 public trash receptacles, 4 pay phones, 4 bus stops with benches, and 7 retail outlets that sell batteries. Surveys cover an area of 29,540 m² (318,000 ft²) and 1,531 m (5,024 ft.) of curb.

**Fig. 1 – Euclid & Superior Case Study
Location and Pavement Survey Areas**

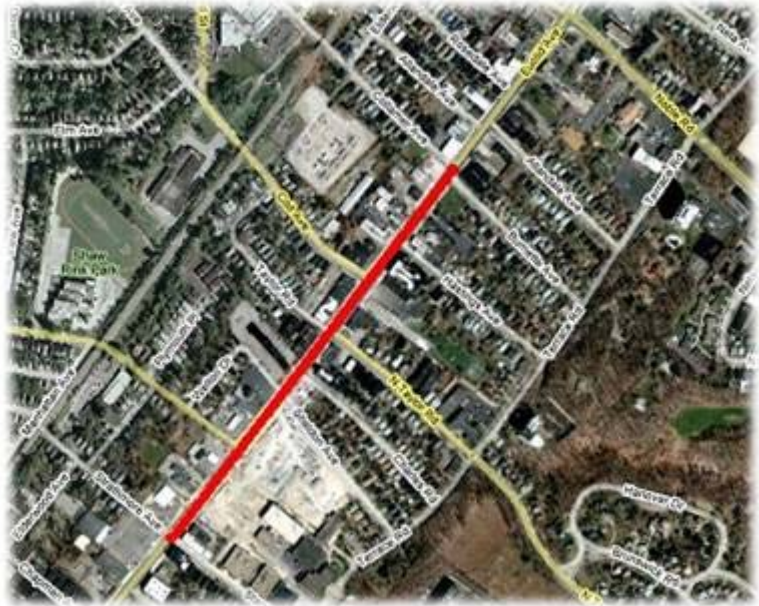
2. Euclid Ave (Holyoak to Lee) ($N41^{\circ} 31.783$, $W81^{\circ} 34.950$). – This site extends along Euclid Ave. from Holyoke Ave. to Lee Blvd. in the City of East Cleveland, OH. The site supports retail outlets, fast food restaurants, churches, an auto dealership, high density housing, and East Cleveland municipal offices. The East Cleveland Center shopping center and the Windermere Regional Transit Authority (RTA) parking lots are adjacent to the north boundary of the site, but neither is included in site surveys. Within the survey area there are 7 public trash receptacles, 4 pay phones, zero bus stops with benches, and 4 stores that sell batteries. Site surveys cover 1,712 m (5,618 ft.) of curb and an area of 27,500 m² (296,000 ft²).

Fig. 2 – Euclid Ave (H-L) Case Study Location and Pavement Survey Area

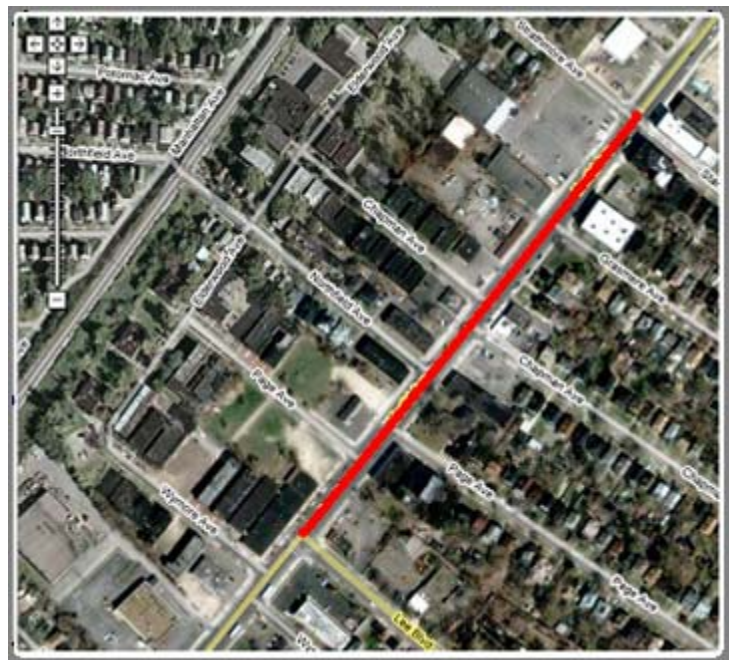
3. Euclid Ave (Lee to Strathmore +Family Dollar) – This is a newly-established site that extends along Euclid Ave. from Lee Blvd. to Strathmore St. and includes both the street pavement and a Dollar Store parking lot in the City of East Cleveland, OH. The site was surveyed in the summer of 2007, but was not characterized in detail. The surveys conducted in 2008 were intended to determine if this should be included as an ongoing case study location.

Fig. 3 – Euclid Ave (L-S +FD) Proposed Case Study Location and Pavement Survey Area

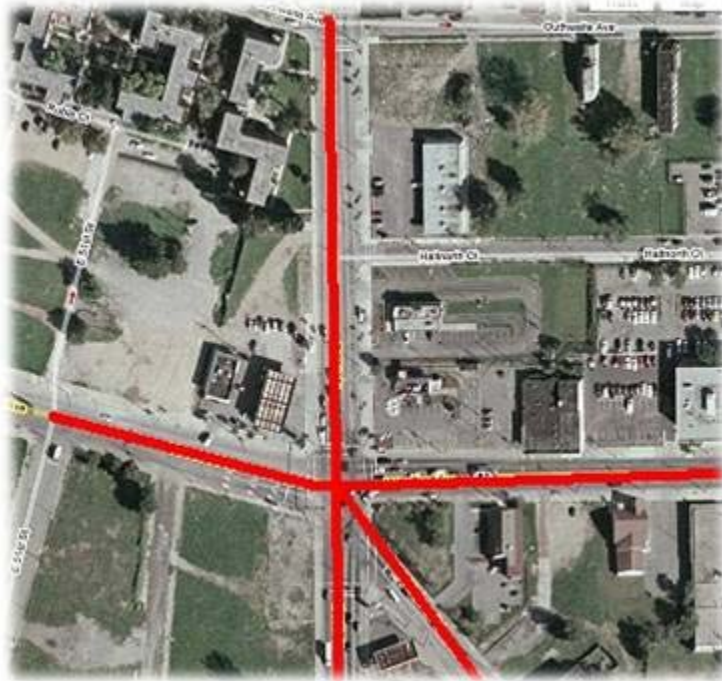
E. 55 St. (N°41 29.284, W8° 39.109) – This site includes 1 block on E.55 St. from Outhwaite Ave. to Woodland Ave. and Kinsman Rd. plus ½ block south of Woodland Ave. on E.55 St., ½ block east and west on Woodland Ave. and ½ block east of E. 55th St. on Kinsman Rd. in the City of Cleveland. This area supports several small stores, 2 gas stations, fast food restaurants, a small grocery store, a police substation and a post office. The main intersection has 4 seated bus stops that support RTA routes on E55th St. and Woodland Ave. There is high density housing adjacent to the northwest corner of the site and high pedestrian grade and high school traffic. Within the survey area there are 9 public trash receptacles, 5 pay phones, 5 bus stops with benches, and 4 retail outlets that sell batteries. Surveys cover 1,251 m (4,105 ft.) of street curb plus the pavement around gas stations and storefront parking. The total surface area is 23,880 m² (257,000 ft²).

**Fig. 5 – E. 55th Case Study
Location and Pavement Survey
Area**

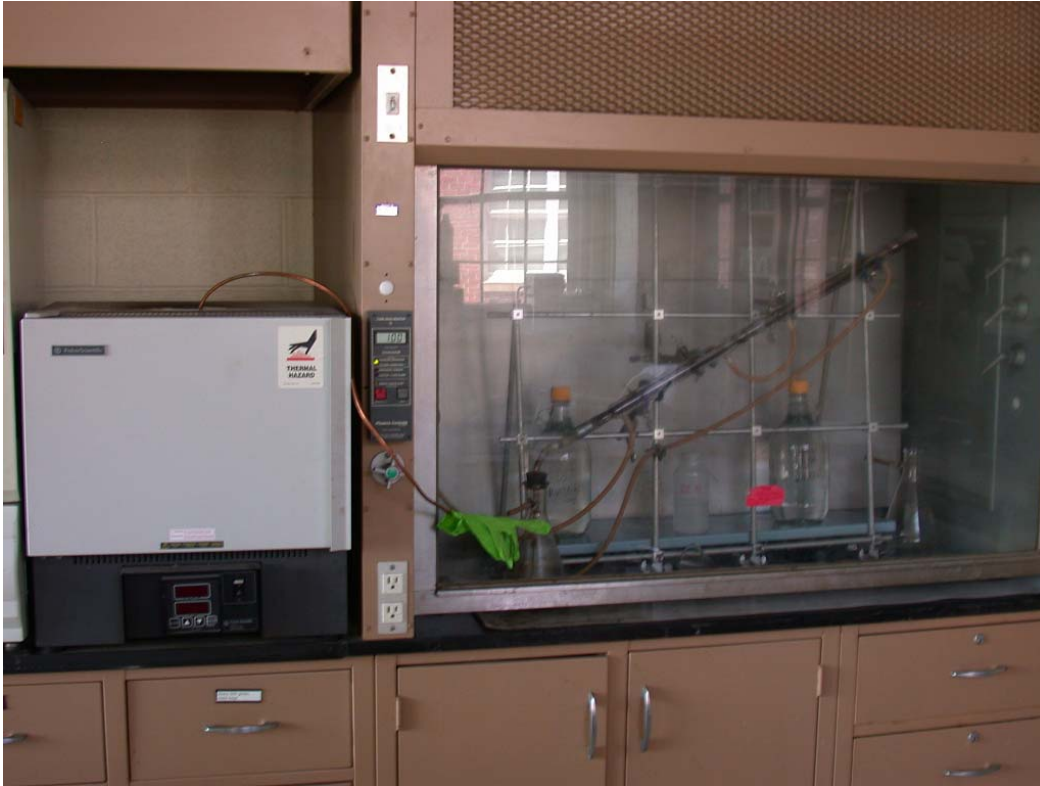
The laboratory-scale apparatus constructed for this project is illustrated in Fig.6. The device makes use of an existing muffle furnace capable of temperatures in excess of 500 C, gas discharged piping and a byproduct recovery system located under a laboratory hood in the Environmental Engineering Laboratory of the Bingham Engineering Building. The apparatus is capable of carbonizing yard waste components in volumes of approximately 1 liter.

Fig. 6 – Laboratory Scale Yard Waste Carbonization Apparatus

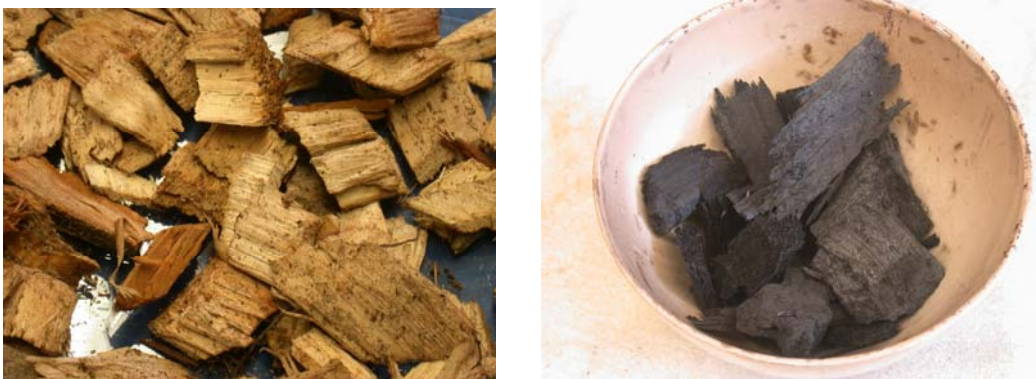
Once the laboratory-scale carbonization unit had been assembled and tested (using hardwood chips) (see Fig. 7) , tests were conducted on 22 yard waste fractions ranging from wet grass clippings to dry hardwood chips (see Fig. 8). All of the yard waste products used were collected in the cities of Shaker Heights and Cleveland Heights on yard waste disposal days.

Fig. 7 - Hardwood chips before and after carbonization

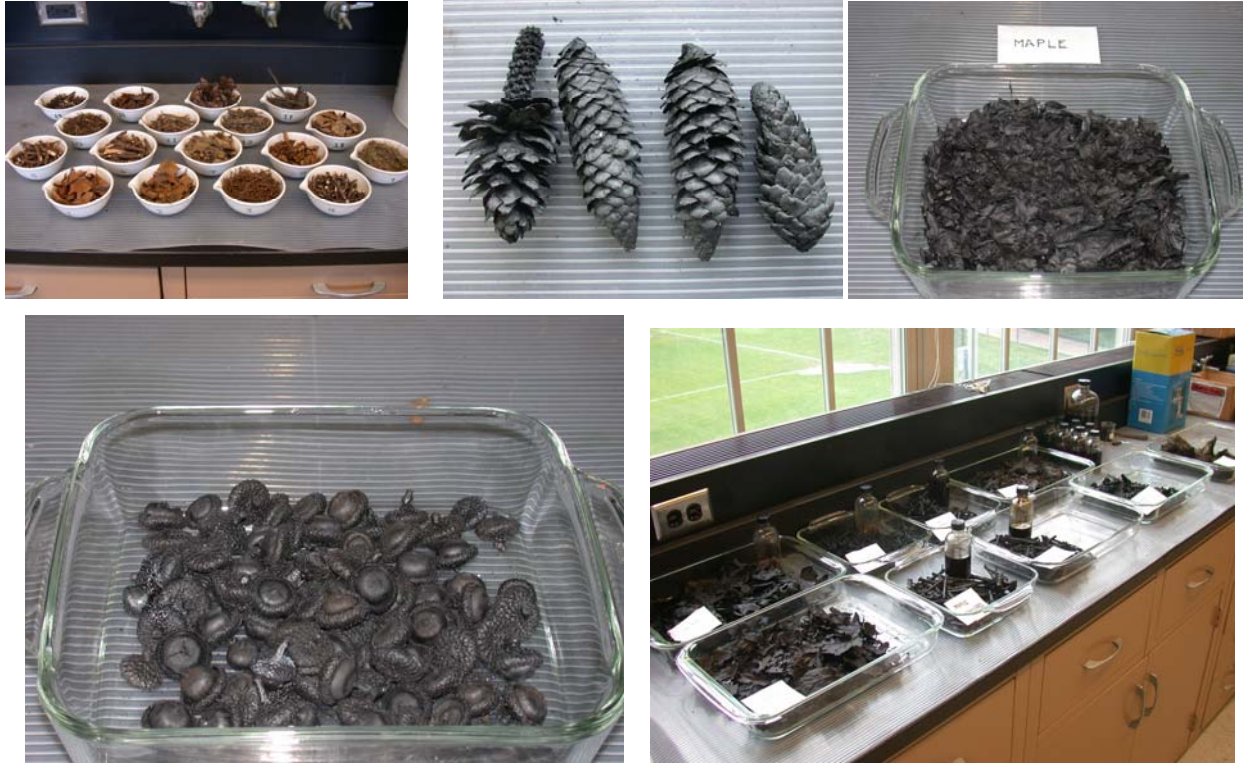
Fig. 8 Yard waste components before and after carbonization

Table 5 summarizes the types of yard waste fractions tested and the fractional yield of charcoal, water (condensed from steam) and organic component recovered from each fraction. During these experiments, it was observed that a bituminous material (AKA wood tar, Pitch, Resin ?) formed (see Fig. 9) and could plug the discharge piping. Originally, this was viewed as a problem, but it was rapidly realize that it is also an opportunity. The piping can easily be designed so it is not plugged by this material, and the bitumen can be collected as a valuable byproduct. This is how wood tars were manufactured before the petroleum era. This could be used in the production of bioasphalt. A research project to explore this aspect of the research has been proposed to the Ohio Department of Transportation.

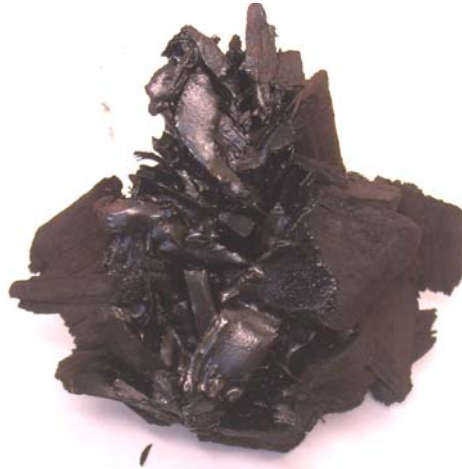
Fig.9 – Bitumen Produced During Yard Waste Carbonization

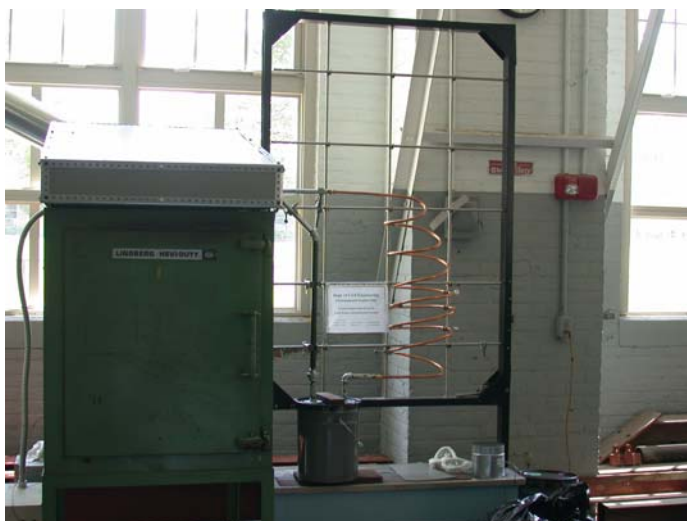
A pilot-scale carbonization apparatus (see Fig. 10) was constructed and tested. An industrial oven was acquired and instrumented with a digital temperature controller. A reactor capable of holding approximately 100 l batches of yard waste was fabricated and installed. A byproduct and offgas recovery system was also fabricated. Dan Hill participated in the design and assembly of all components. Initial tests indicate that the reactor is capable of accomplishing carbonization in about 4 hours. However, the initial tests also indicated that the vent stack used to discharge uncondensed gas may not reach high enough above the Bingham Engineering Building to ensure that offgas is not captured by the building's nearby air intakes. A chimney extension is currently being designed and will be installed before the pilot-scale apparatus goes into full production.

Fig. 10 – Pilot-scale Apparatus for Yard Waste Carbonization and Byproduct Recovery

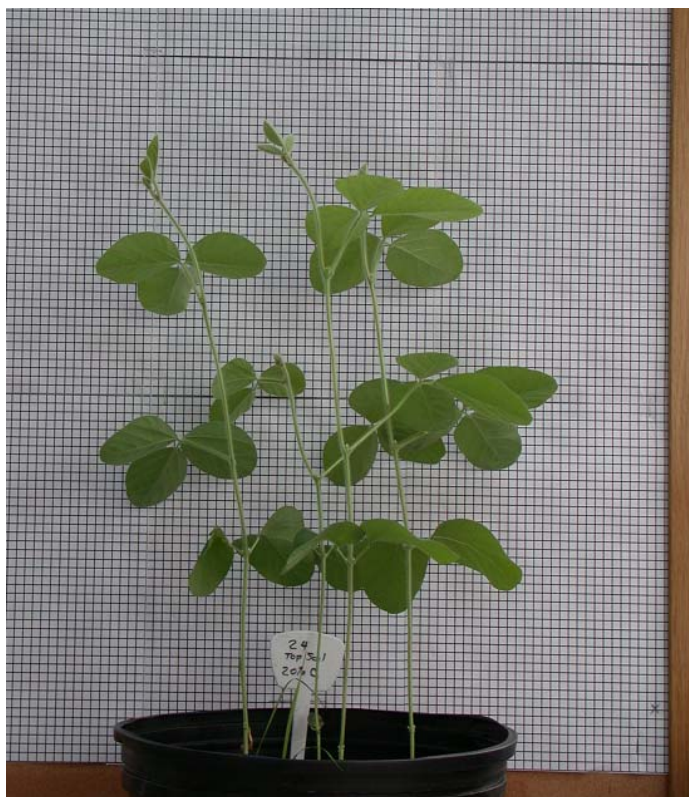
Fig. 16 – Soybean Plant Photographed of Differential Growth Quantification

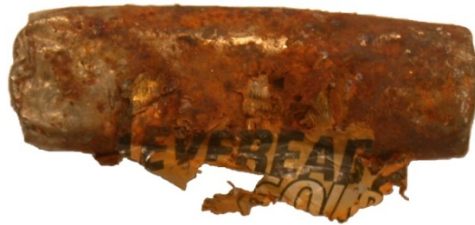
Figure 1: Battery Exhibiting Physical Damage Rating of 3 and Corrosion Condition rating of 2.
