**LsDyna3D Simulations and Analysis of
Polish Governmental Airplane TU-154M
Crash in Smolensk, Russia, April 10, 2010**

Wiesław K. Binienda, Ph.D., F.ASCE

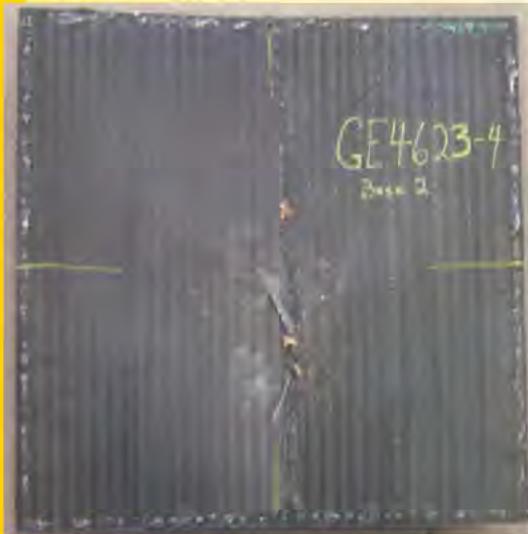
Impact Velocity = 740ft/s

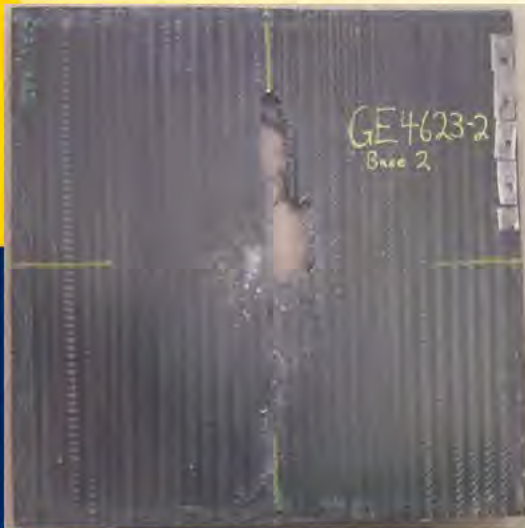
Impact Velocity = 823t/s

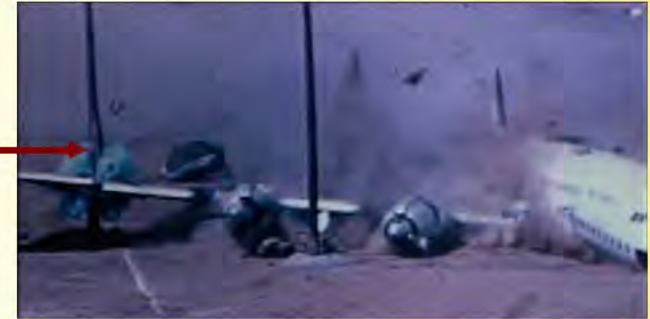
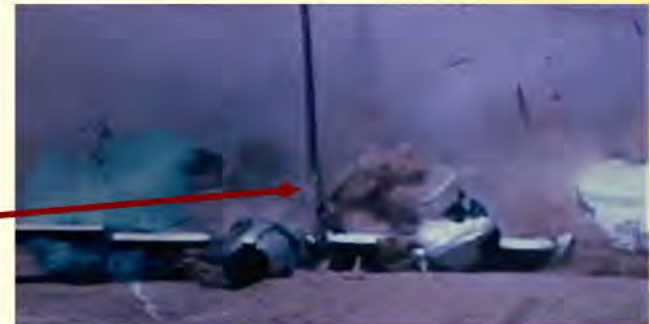
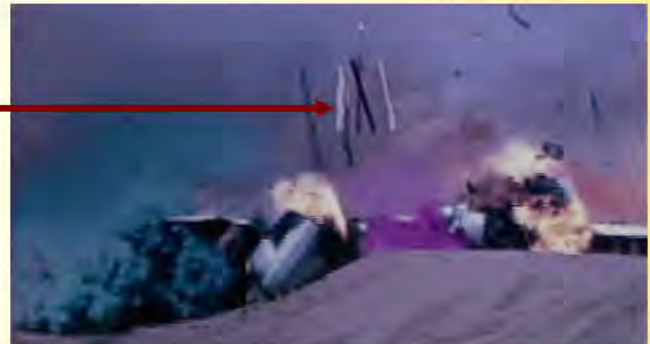
Simulation Agreed with FAA Experiment

- Inboard pole is cut by the wing
- Inboard tank compromised after impact with ground
- Outboard tank damaged by impact with the second pole, outboard pole is also cut
- Both poles fell in the direction of the airplane movement
